a. This is an interim report on the accelerated phase of the "Operational Suitability Test of the RB-57A Aircraft," Project No. APG/TAT/122-A. The test was initiated in accordance with APGC Letter Directive, dated 28 October 1953.

**RB-57A Aircraft**

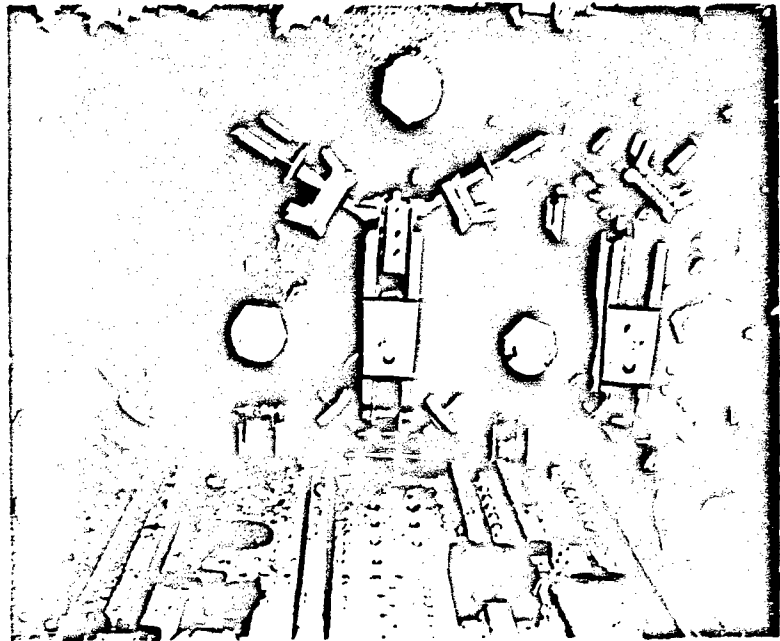
**PHOTO 13**

Front view of M30 GP Bomb in forward bay showing sway braces fully extended yet barely touching ogive of bomb.

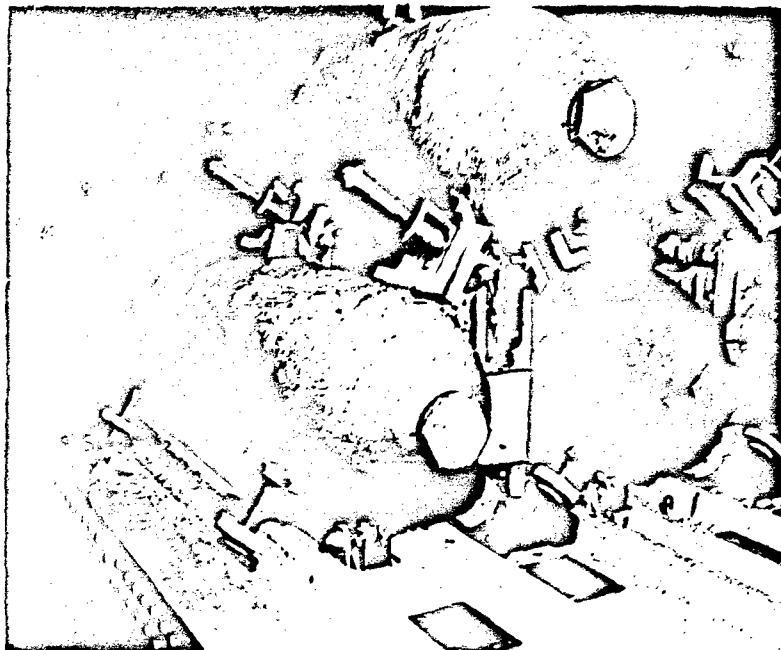
**PHOTO 15**

M30 GP Bomb properly installed  
in center bay. Center and rear  
bay installations of this bomb  
are satisfactory.

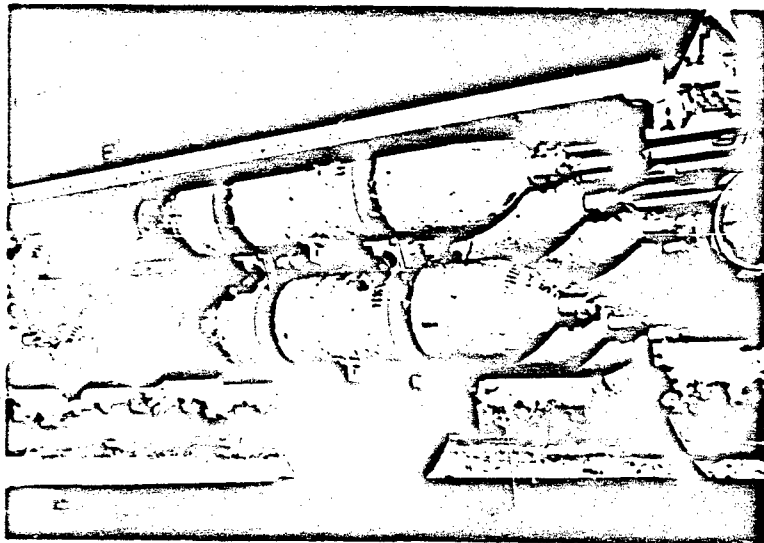
**PHOTO 28**

M-120 Bombs, fuzes and arming wires after exposure in slip stream for five minutes at 250 knots.
